Navigation Wiring Modifications

1998 740iL

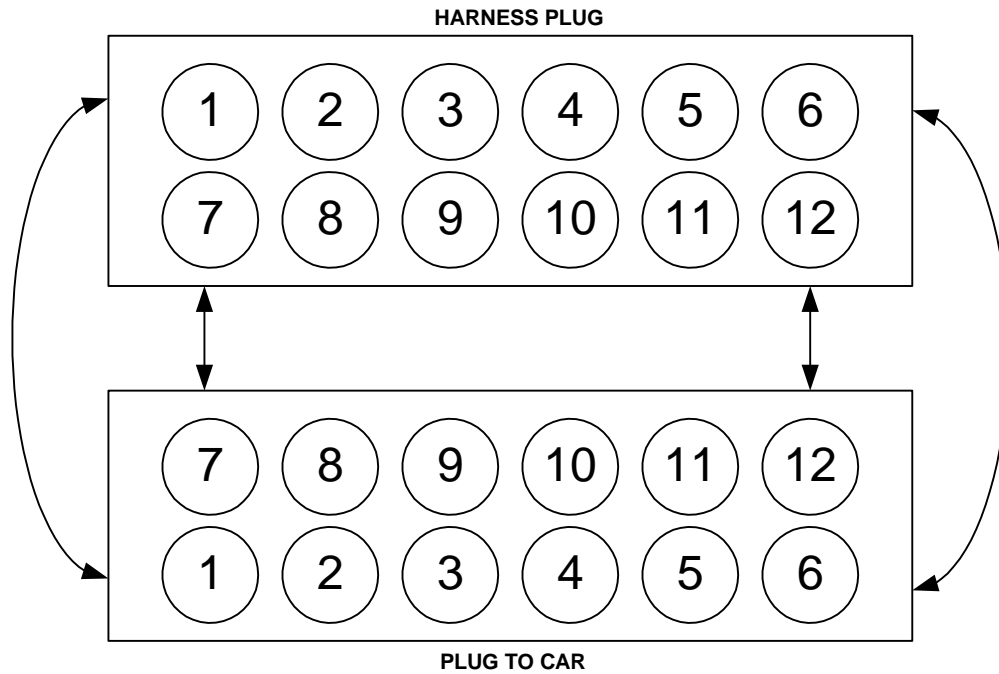
| 1 - N/C | 7 - N/C (was purple/white) |
| 2 - White/Green | 8 - Gray/Red |
| 3 - Black/Brown | 9 - White/Yellow/Gray |
| 4 - Black/White | 10 - Black/White |
| 5 - White/Brown | 11 - Purple/Red |
| 6 - Brown (big) | 12 - Red/Green (big) |

- 1) The purple/white wire (ignition sense) on the harness plug has no matching wire on the car connector. This wire was removed and connected to the other purple/white wires attached to the body next to the rear lights.

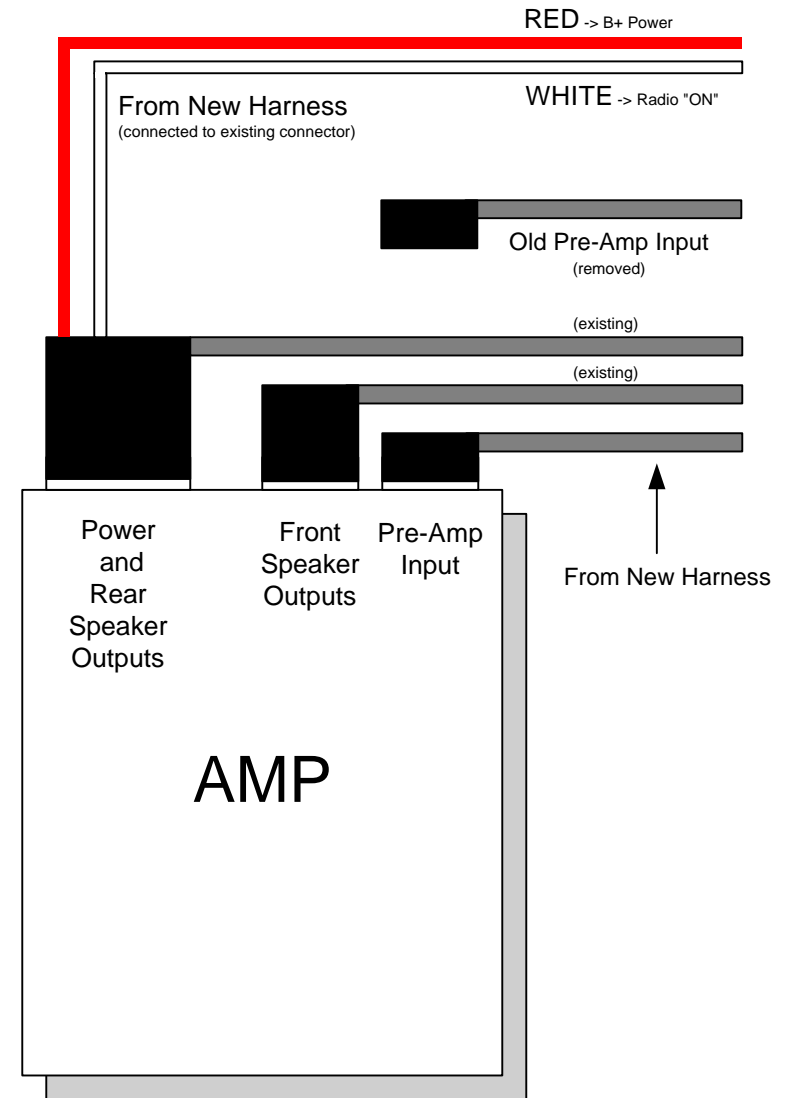
| 1 - N/C | 7 - N/C |
| 2 - White/Green | 8 - Gray/Red |
| 3 - Black/Brown | 9 - White/Yellow/Gray |
| 4 - Black/White (big) | 10 - Black/White (small) |
| 5 - White/Brown | 11 - Purple/Red |
| 6 - N/C | 12 - Red/Green (big) |
